# Manhole Inspection Summary

Manhole # S11KK\_016MH

**Location** Address: **3201 CLIFTON AVE** Cross Street: **WALBROOK ST**

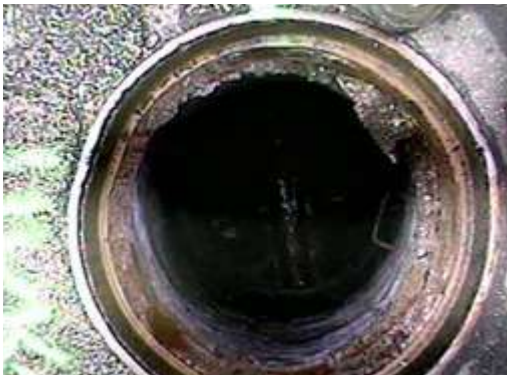
Top View

**Frame** Offset: **2** (in.) Condition: ☒ Sound ☐ Cracked ☐ Leaks

FRAME OFFSET

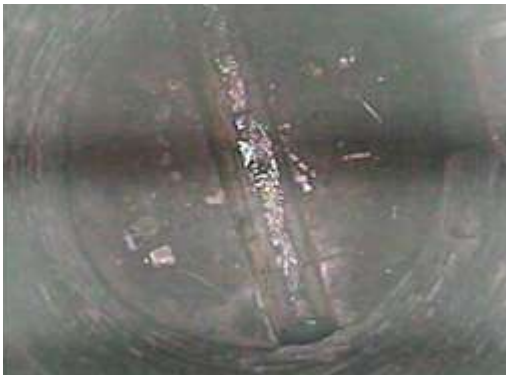
Defect 1

**Steps** Count: **5** Missing: **2** ☒ **Corroded**

CORRODED STEPS. DEBRIS ON BENCH

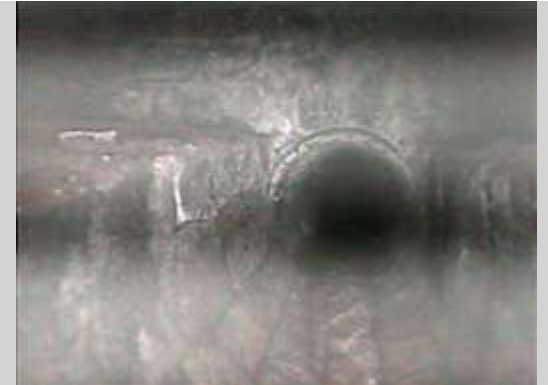
12 O'Clock Outflow

8 in. Circular Gravity Sewer  
Pipe Out @ 12 O'Clock

Invert Depth: **9.69** (ft.) Flow Characteristics: **Slow**

Deposits: ☒ None ☐ Mud ☐ Sludge ☐ Debris ☐ Grease

Infiltration: **None** Pipe Seal Cond: **Sound**

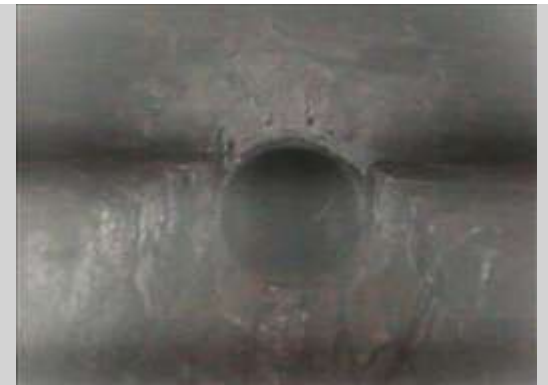
6 O'Clock Inflow

8 in. Circular Gravity Sewer  
Pipe In @ 6 O'Clock

Invert Depth: **9.68** (ft.) Flow Characteristics: **Slow**

Deposits: ☒ None ☐ Mud ☐ Sludge ☐ Debris ☐ Grease

Infiltration: **None** Pipe Seal Cond: **Sound**
